Loveland Regional Improvements Blight Study

Section 1: Study Overview

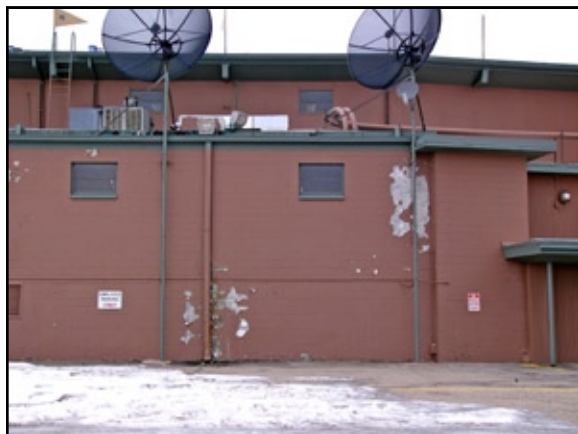
The dog kennel and dog track facilities show significant signs of deterioration. On Block 1, the kennel facility includes a vacant single-family residence plus numerous smaller buildings that sheltered the dogs. Both the dog shelters and the residence exhibit significant deterioration problems with their roofs, exterior finishes, windows, doors, and general disrepair of minor ancillary structures.

The dog track facility in Block 5 has deterioration issues in its exterior finishes, windows, and doors. A small ancillary structure next to the main track facility showed significant deterioration, including a collapsed roof.

Both the dog kennel and the dog track showed signs of exterior deterioration.

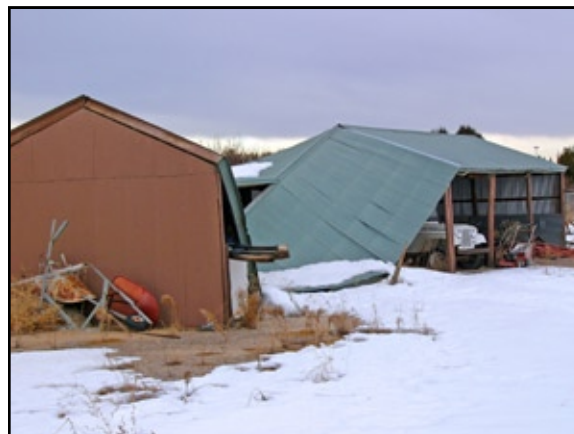
An ancillary structure at the dog track had partially collapsed.

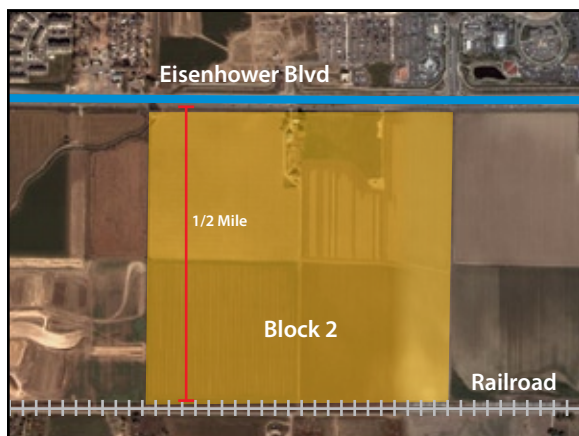
The historic and current use of most of the land in the Study Area for agricultural purposes has resulted in a transportation infrastructure that is generally minimal and of low-capacity. However, even from an agricultural use perspective, there are portions of the Study Area with inadequate access and poor internal circulation.

The only access to Block 2 is along the northern border via Eisenhower Boulevard.

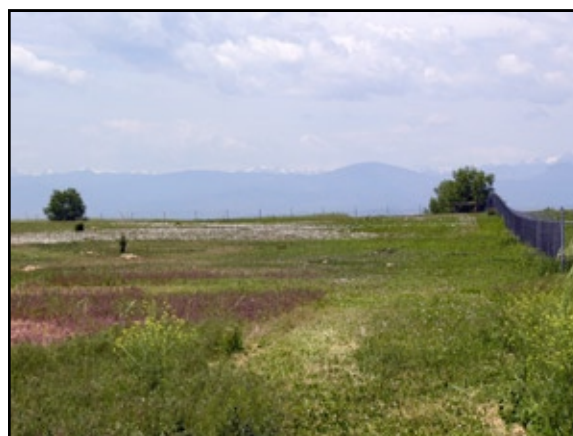
For example, presence of railroad tracks and a canal along the south side of Block 4 contributes to the lack of access from the south, and no roads exist to provide access from the north or east. Block 2 is similarly bordered by only one road, Eisenhower Boulevard, as no north-south roads exist on either side of the quarter-section parcel, and railroad tracks inhibit access along its southern border from County Road 20E. Block 1 is also hindered from having roadway access along its eastern edge due to railroad tracks. Block 3, which does have some direct frontage along Eisenhower Boulevard to the south, lacks access to the north due to railroad tracks.

The northern and eastern sides of Block 4 have no vehicular access.

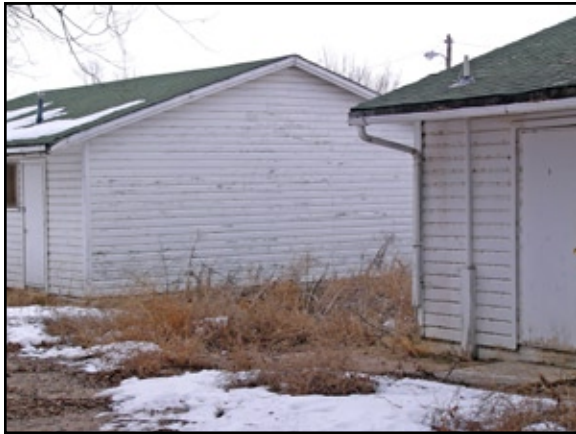
While the agricultural portions of the Study Area generally have few site improvements, there are two notable places in the Study Area used for non-agricultural purposes that have significant site improvements: the dog kennel in the southwest corner of Block 1 and the dog track that encompasses most of Block 5. These developed parcels' aging site improvements are in varying states of disrepair. Both properties show general site maintenance deficiencies, and the dog track has further problems with its large, deteriorating paved parking lot, as well as aging lighting fixtures and signage. Furthermore, the track's parking lot is poorly laid out, in addition to its noticeable disrepair. The kennel facility on Block 1 has significant overgrown vegetation and other signs of deteriorated improvements such as fences, gates, and the driveway/parking areas.

Overgrown vegetation proliferate the dog kennel site.

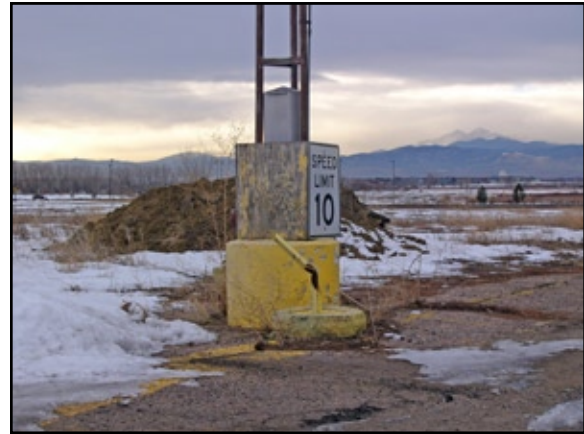
Site improvements in and around the dog track parking lot showed signs of deterioration.

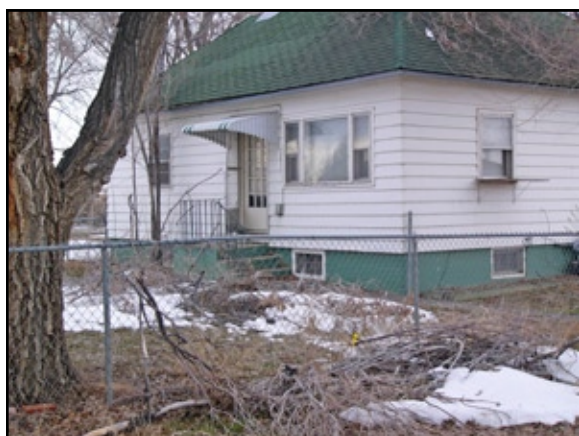
All of the buildings at the kennel facility on Block 1 are currently vacant and the entire kennel property is not being used for any active purpose. While elements of the dog track facility appear to have some occasional use, the vast majority of the land area of Block 5 is covered by surface parking that sits unused. Consequently, it is the opinion of the consultant team that Block 5 is underutilized given its developed state and its location near other developed parcels.

The kennel property on Block 1 contains many vacant kennels and a vacant residence.

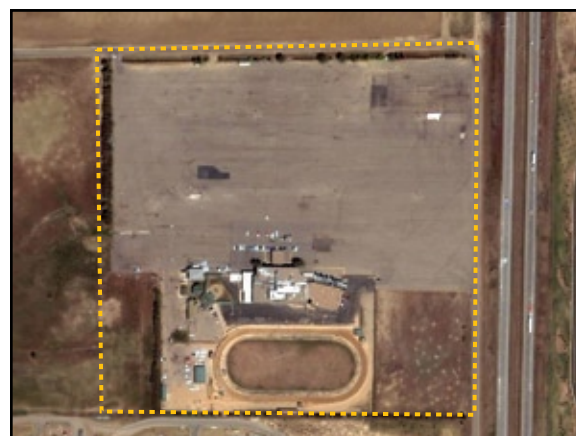
Block 5 is mostly devoted to parking or is otherwise undeveloped, with the dog track facilities occupying a relatively small portion of the land.
